**FULL-SCALE DYNAMIC CRASH TEST
OF A
DOUGLAS DC-7 AIRCRAFT**

TECHNICAL REPORT

by
W. H. Reed
S. H. Robertson
L. W. T. Weinberg
L. H. Tyndall

**Aviation Safety Engineering and Research
Division of Flight Safety Foundation, Inc.
Phoenix, Arizona**

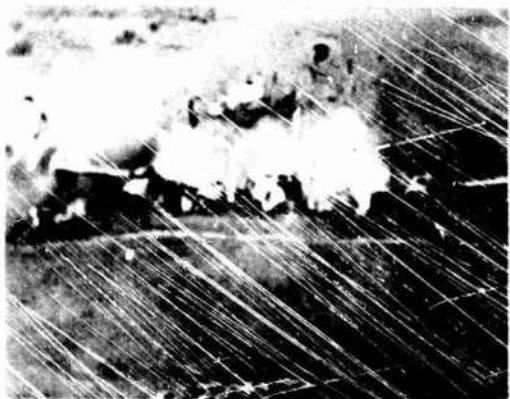
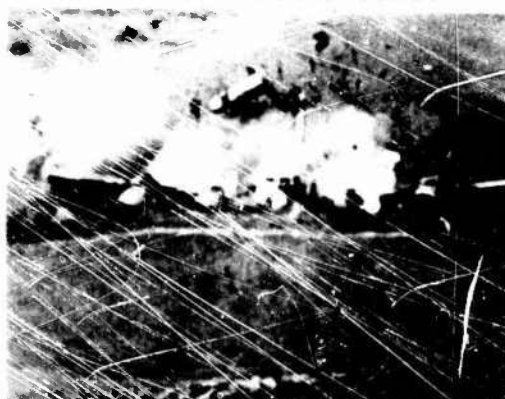
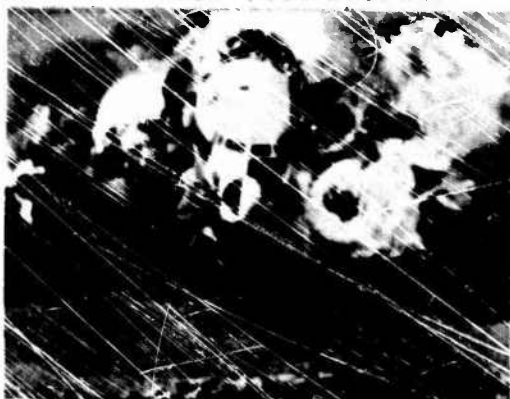
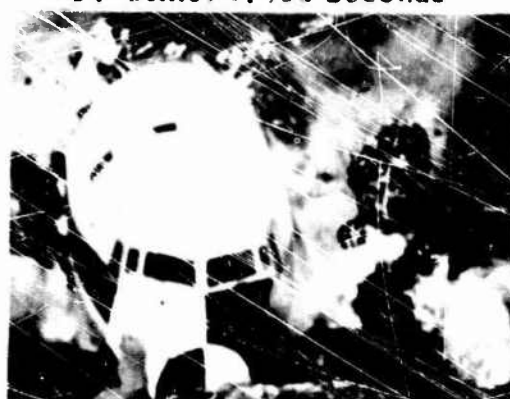
FIG. 30 SEQUENCE PHOTOS OF CRASH, SEEN FROM TOP
OF 20 DEGREE SLOPE

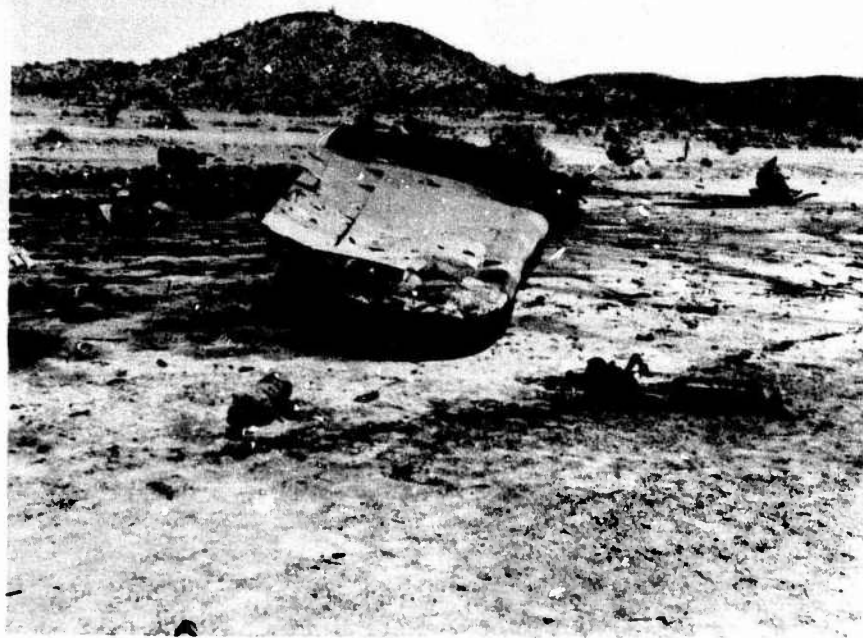
FIG. 32 POSTCRASH VIEW OF LEFT WING WHERE IT CAME TO REST LYING 50 FEET AHEAD OF MAJOR AIRCRAFT WRECKAGE

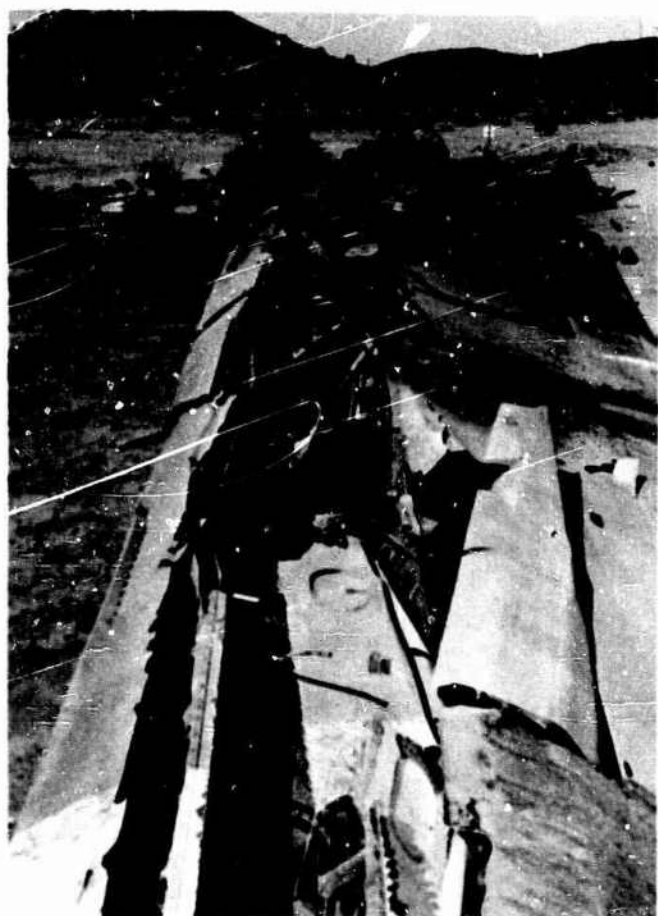
The wing was extensively torn and deformed in the wing root area, as would be expected with any gross structural failure.

FIG. 33 SPANWISE SEPARATION OF UPPER SKIN ON LEFT WING AS VIEWED FROM WING TIP TOWARD WING ROOT AREA

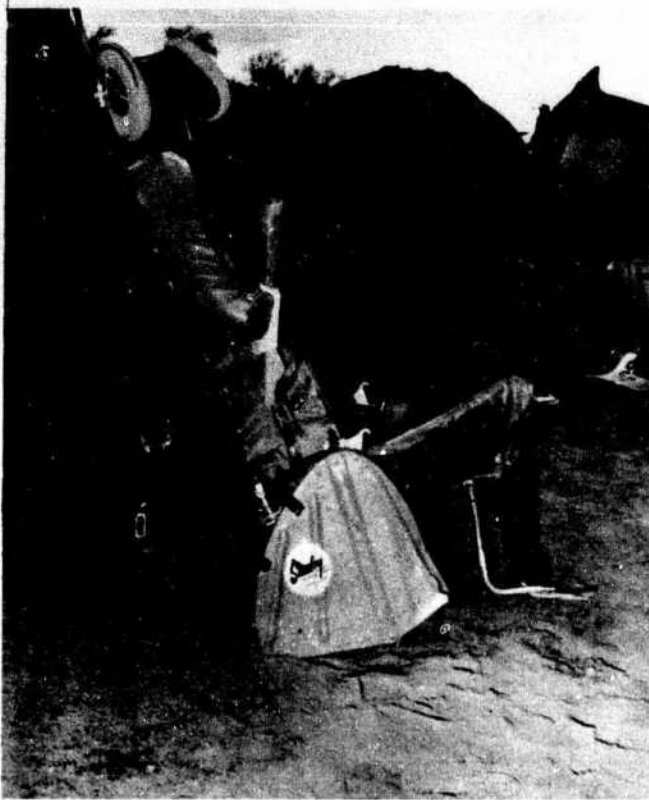
FIG. 44 RIGHT SIDE VIEW
OF PILOT SEAT
AFTER REMOVAL
FROM WRECKAGE

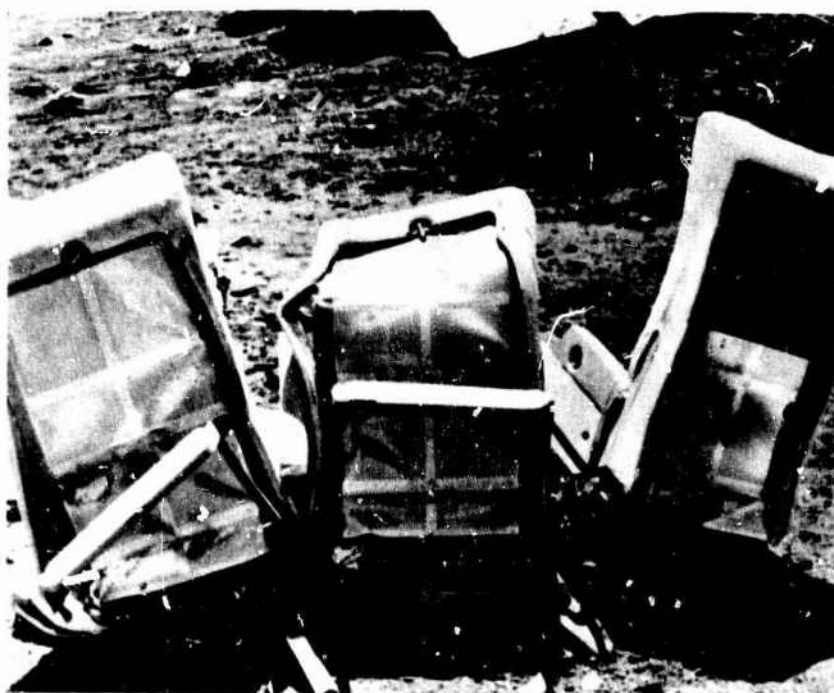
FIG. 73 REAR VIEW OF OCCUPIED THREE PASSENGER
FORWARD FACING SEAT AFTER REMOVAL FROM
WRECKAGE
